# Fax

Ali Bahrami  
Directorate Manager, ANM-100  
Transport Airplane Directorate  
Aircraft Certification Service  
Federal Aviation Administration (FAA)  
1601 Lind Ave. SW  
Renton, WA 98055-4056

I am reporting the fraud I witnessed in the Quality Assurance Department of the following company:

Accra Manufacturing  
17703 15th Ave S.E.  
Bothell, WA 98012

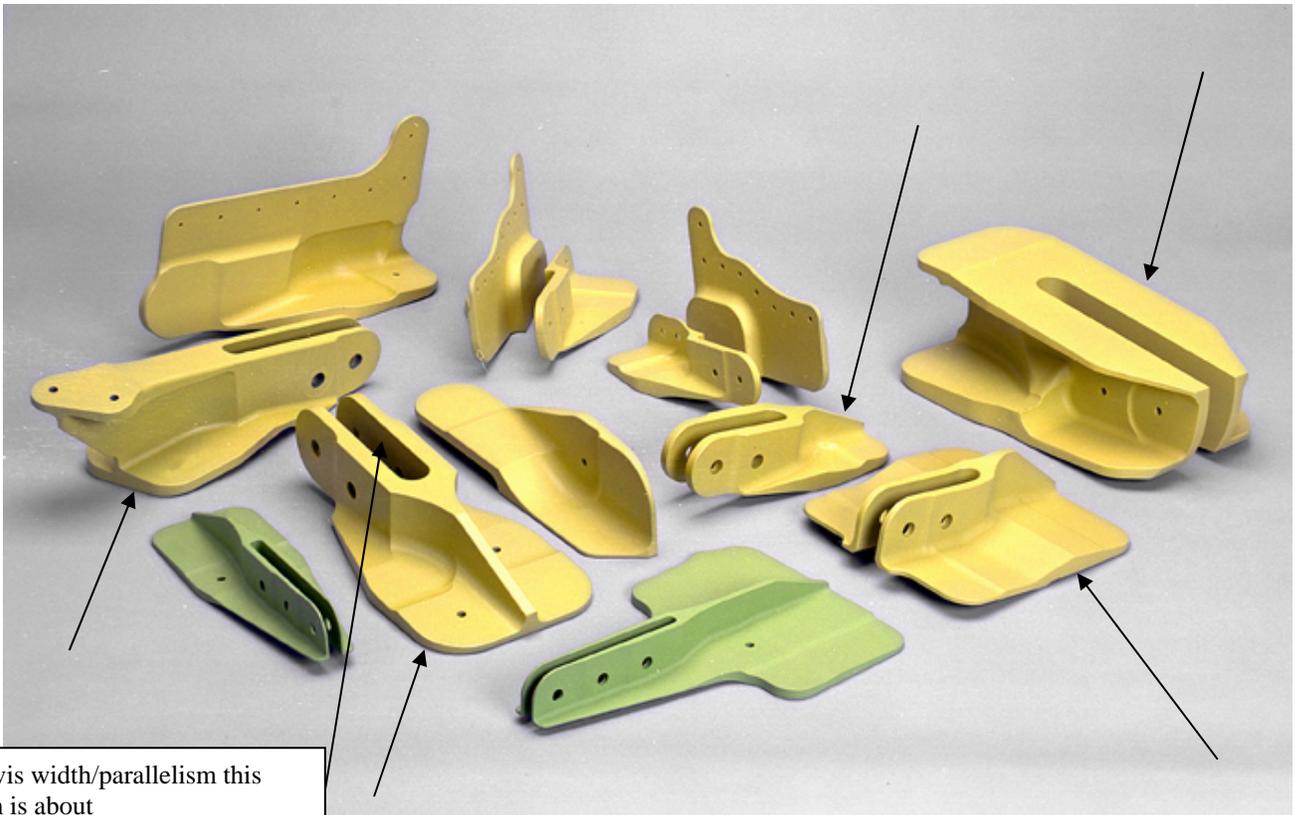
Above is a picture of the noted fittings from the Accra website. The type of fittings at issue are the yellow (fuel tank primered) integral wing/fuel tank fittings with clevises, including and similar to the ones the arrows point to.

Anyway, the first time I inspected a lot of parts per this inspection, I found many parts in the lot out of tolerance. To my memory, this inspection was to check per a drawing requirement that the two sides of the clevis part of the fitting be parallel to within a certain dimension on the inside of the clevis over the length of the parallel surfaces, presumably to ensure fit-up/easy shimming/minimum preload of the clevis at assembly. I didn’t document the specified required dimension and what I measured, but I believe that parts I measured per this inspection were .010” or more out of tolerance, with the clevis lugs bowed out.

Apparently, after the paddle/splice fittings are machined, the clevis width bows out of tolerance due to post machining processes—most likely shot peening, in this case. That is why, I believe, the inspections for the clevis width being out of tolerance were scheduled on the production paperwork to be after the parts were received from penetrant inspect/shot peen/anodizing/finishing processors they were sent out to after post machining inspection.

Of course, the parts and paperwork will not lie. Have your investigators check stock on hand for this discrepancy (on dock, back from processor, in stores, and in the part mark/shipping area). If parts are not discrepant, check their nonconformance system and production paperwork scanned in their archives to see when they began to address and eliminate these discrepancies, rather than just shipping the defective parts to Boeing.

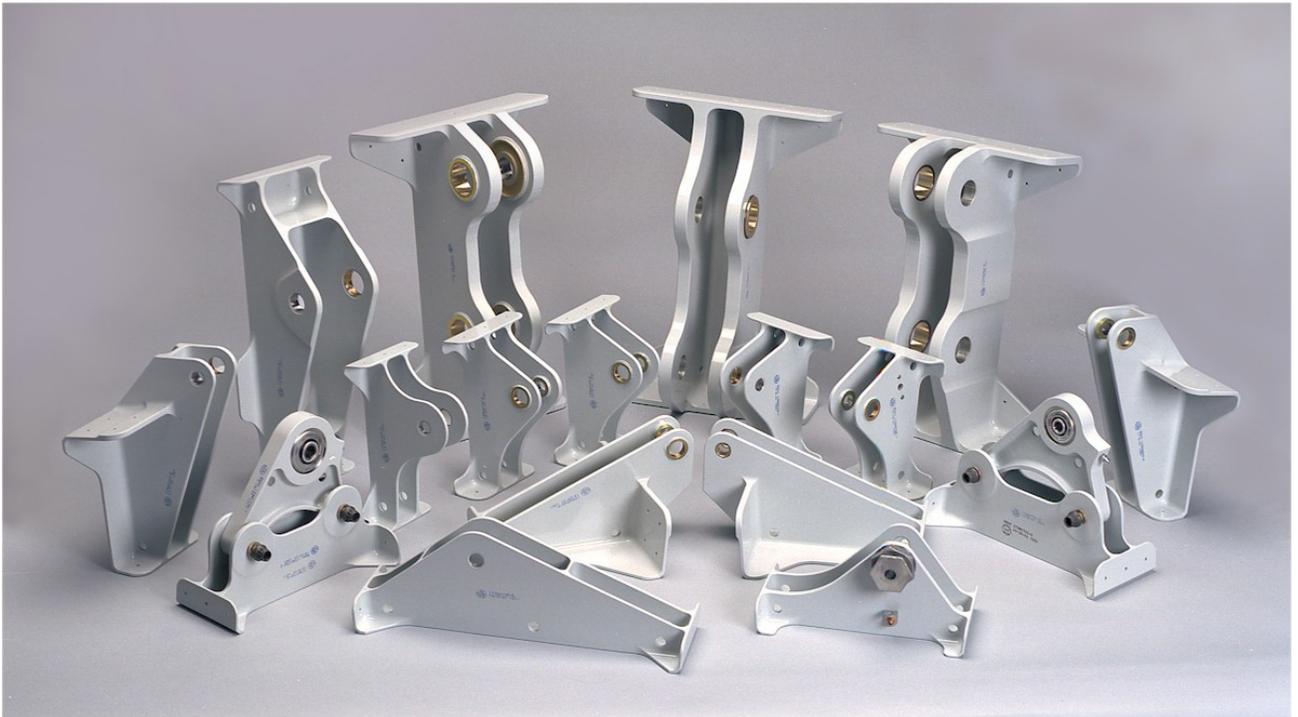
[REDACTED] told us to not perform required inspection of bore diameter of the horizontal/vertical stabilizer fittings that Accra manufactured—specifically, not to inspect the bore diameter of the fitting if a bushing was later installed into that bore.

Above is a picture from the Accra website ( [www.accramfg.com](http://www.accramfg.com) ) showing some of the vertical/horizontal/wing trailing edge fittings this item concerns (because Accra was an assembly manufacturer, I don't know (and didn't need to know) exactly where on the airplane each of these fittings were installed).

Being directed to ignore the mandatory inspections of these bores prior to bushing installations was fraud of the highest order. These were the bushings/fittings on which the control surfaces of the airplane pivoted, and the consequences of a loose/galled bushing or a fitting cracking because the bore in the fitting was undersize/scratched cannot be over-emphasized.

Please inspect all fittings in process that do not have bushings installed into their bores yet to find out what kind of discrepancies we were told to not inspect for as required.

Please ensure appropriate corrective action is taken, including capturing of intentionally escaped discrepancies.
